The Mansfield

Old Building Handbook

A Guide to Architectural Styles and Rehabilitation Techniques

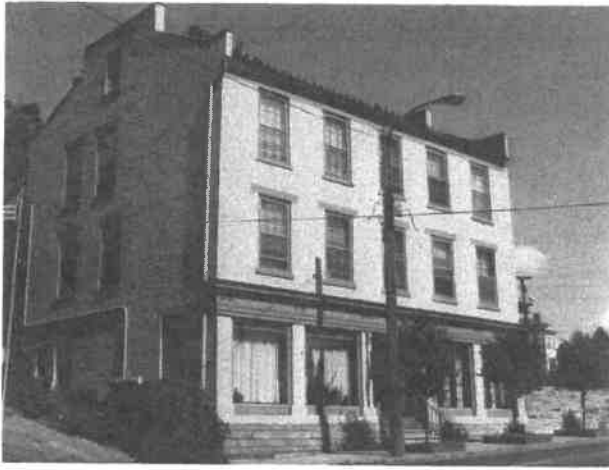
Stage Coach Inn
60 S. Main Street (1814)

The Federal style was brought to the U.S. from England and makes use of classical elements. Mansfield has an early vernacular example in the Stage Coach Inn on South Main Street. The Federal style is characterized here by smooth wall surfaces, the bridged chimneys at each gable end, multi-paned windows, and a small oval window (not pictured) on the north side.

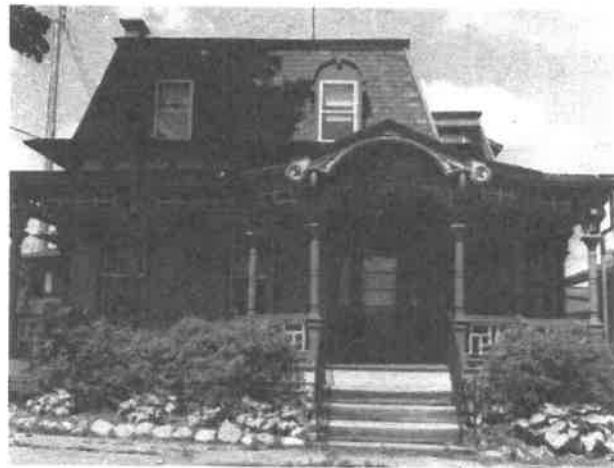
**14 Lexington Avenue
(c. 1880)**

This style derives its name from the reign of French Emperor Napoleon III (1852-1870). French Second Empire achieved its greatest popularity in the U.S. in the 1870s, when it was employed extensively for public buildings (including the third Richland County Courthouse in 1873). This Lexington Avenue house is one of the few surviving examples of this style in Mansfield. The defining feature of Second Empire is the mansard roof, usually with dormer windows. Other ornamentation was borrowed from other Victorian styles, such as the Eastlake style porch and Italianate cornice in this example.

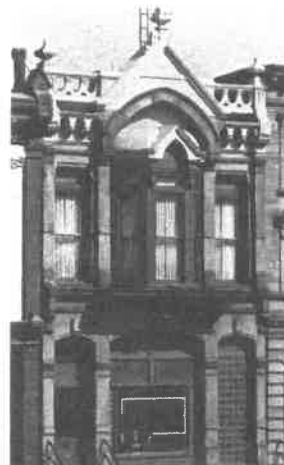
**25 East Third Street
(1882)**

High Victorian architecture places an emphasis on verticality and variety in color and texture. High Victorian Gothic buildings use the pointed arch (as the word Gothic would indicate) and different materials to create variation in color. The Third Street brownstone is an excellent example of this style. High Victorian Italianate, represented by the Bissman Building on North Main Street, is distinguished by its window treatments which form shadows and create an ornamented facade.

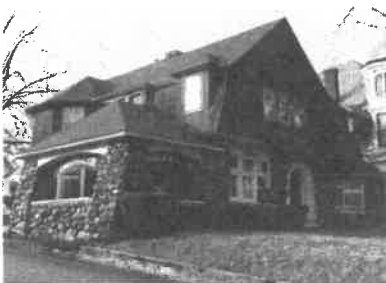
**429 Park Avenue West
(c.1900)**

An adaptation of Queen Anne architecture, the Shingle Style was more common to the coast of New England than to communities of the Midwest. In Mansfield, the style is represented by this Park Avenue West house. The style is characterized by a wall surface of wooden shingles which envelopes the building. Sometimes, the ground story walls are stone, as in the pictured example where fieldstone is used.

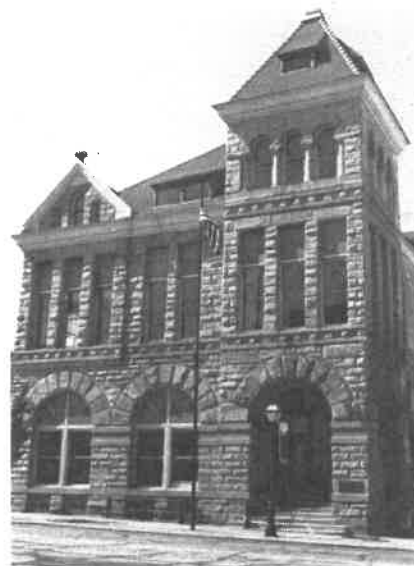
**Soldiers and Sailors
Memorial Building
36 Park Avenue West
(1889)**

This style was named for H. H. Richardson, a Boston architect who originated the style during the 1870s and early 1880s. Constructed of masonry, Richardsonian Romanesque is defined by the rounded Roman arch which is made massive and heavy by the use of rock-faced stone. Sometimes round-arched or straight-headed windows may be grouped with stone columns between them. Also common was the square tower, rounded turret or projecting bay with high-pitched roof. Richardsonian Romanesque was especially suited to public buildings such as Mansfield's Soldiers and Sailors Memorial Building and the Masonic Temple which stood on North Main Street.

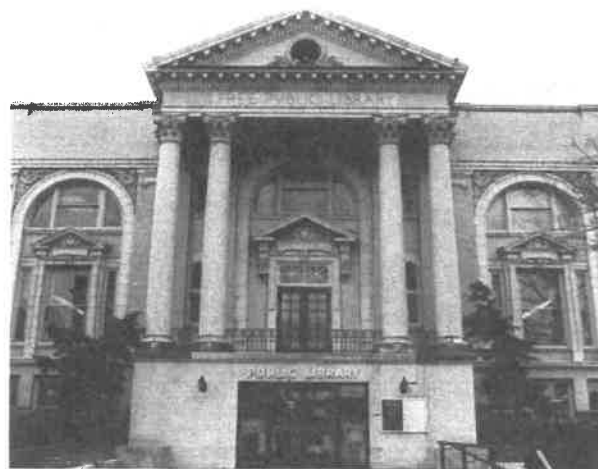
**Mansfield-Richland County Public
Library
43 West Third Street
(1908)**

A style often used for public buildings, Beaux-Arts Classicism grew out of the Ecole des beaux-arts in Paris during the late 19th century. The style commonly features symmetrical facades, paired columns, monumental flights of steps, and classical ornamentation. The Mansfield-Richland County Public Library is a good example of the style (the front steps have been removed).

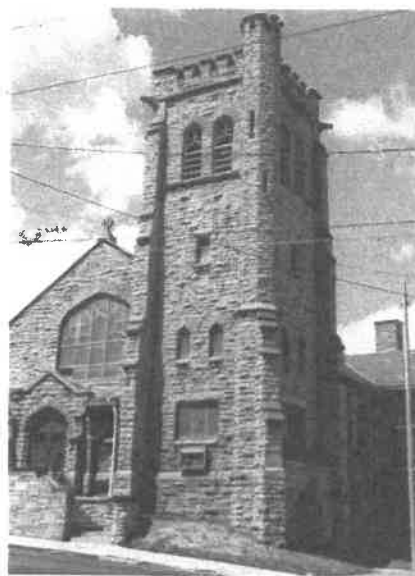
Grace Episcopal Church
41 Bowman Street
(1909)

Late Gothic Revival draws upon earlier Gothic forms, including an emphasis on verticality and the pointed arch. The style was especially favored for churches built of masonry, often stone. Mansfield has several churches from the early 1900s which are noted as good examples of this style, including Grace Episcopal Church, First United Methodist Church, and St. John's Evangelical Church.

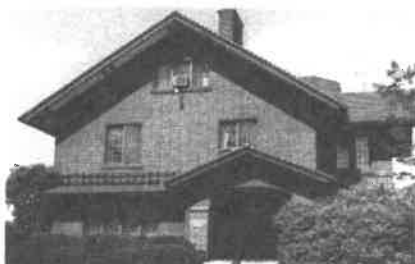
Scattergood House
42 Blymyer Avenue
(c. 1915)

*The Bungalow house is a building type which is closely identified with the early 20th century Craftsman movement promoted by Gustav Stickley in his magazine, **The Craftsman**. These buildings feature strong horizontal lines and native materials such as stone, stucco, and wood shingles. A characteristic feature of the Bungalow is the front porch which is built into the house, wide overhangs with kneebrace or triangular brackets, and exposed rafters under the eaves, as in this Glenwood Boulevard example. The Scattergood House on Blymyer Avenue provides another example of the Craftsman influence.*

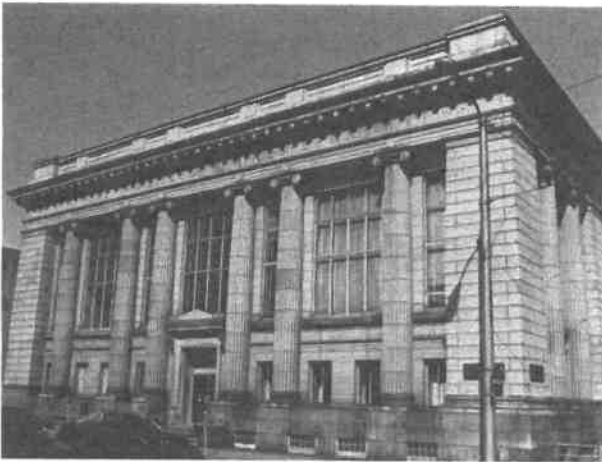
**Mansfield Savings Bank
4 West Fourth Street
(1913)**

This style represented a return to classical forms during the early 20th century. The Mansfield Savings Bank provides a characteristic example of the style. Typically, the Neo-Classical Revival style features broad expanses of wall surface, flat rooflines, straight-topped windows and doors, columns and other classical ornamentation. The use of a front pedimented portico or pavilion is common.

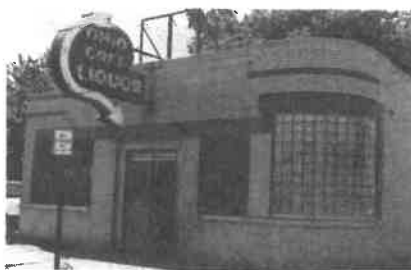
**Ohio Cafe
296 East Fourth Street
(c. 1938)**

Art Moderne is similar to Art Deco, but its ornamentation is even more restrained and flat. The style makes use of geometric influences and curved surfaces, such as the rounded glass block window in the Ohio Cafe. The Zediker Apartments provide another local example of the Art Moderne influence.

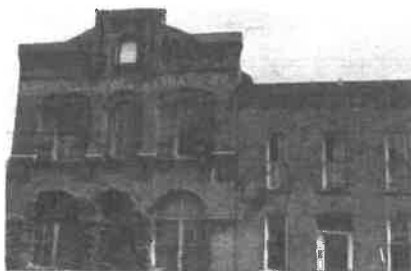
**Mansfield Cold
Storage Company
25-29 East Sixth
Street (c. 1887)**

As a major industrial center, Mansfield has a large collection of historic manufacturing and warehouse buildings. Buildings from the late 1800s and early 1900s sometimes exhibit stylistic features, as in the Mansfield Cold Storage Warehouse. Other buildings are more functional and vernacular in appearance. The city has many important examples of industrial structures. The City Mills Building is an early flour mill which displays a monitor roof (central raised section with windows) used to admit light to work spaces.

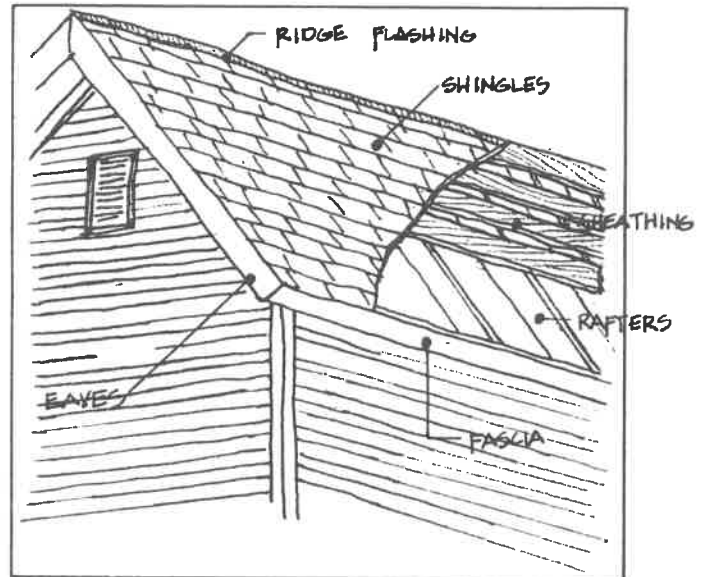
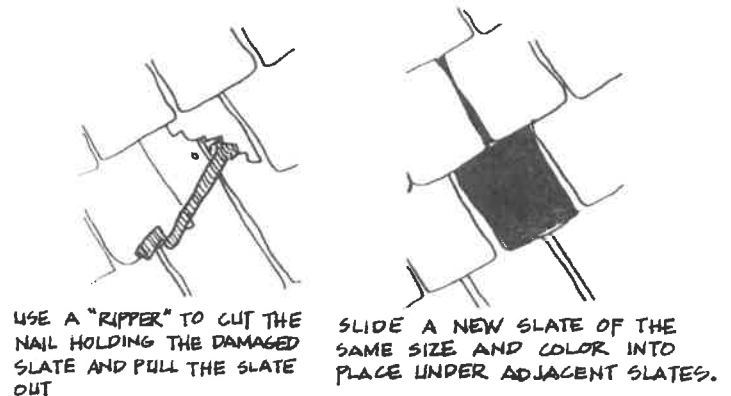
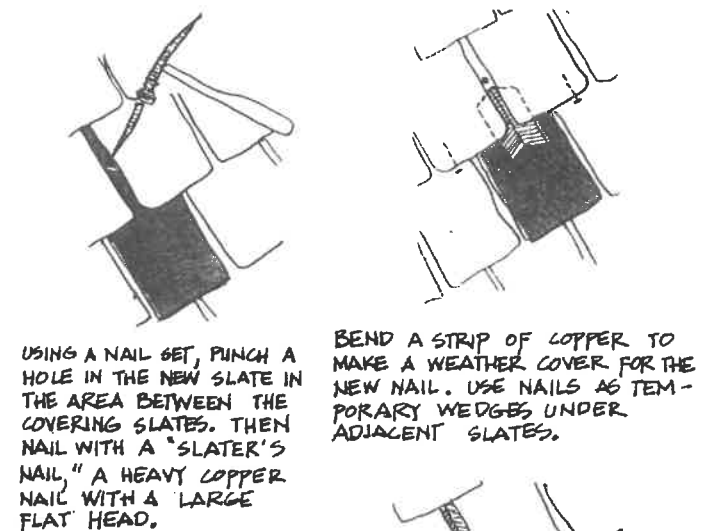
Drawing R-1: Components of a Typical Roof

Drawing R-2: Slate Replacement
(Adapted from a drawing by Robert D. Loversidge, Jr. from the **Old Building Owner's Manual** by Judith L. Kitchen, with permission.)

Individual shingles (wood, slate, clay tile or asphalt) are relatively easy to replace, as illustrated in Drawing R-2. In replacing roof shingles, make an extra effort to match the new material with the existing in size, texture and color. Mismatched roof materials look haphazard and can spoil the appearance of your building.

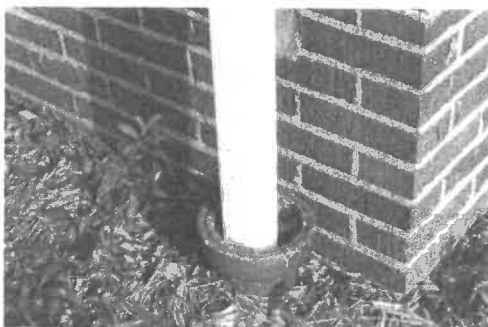
An example of a downspout which ties into an underground drainage system.

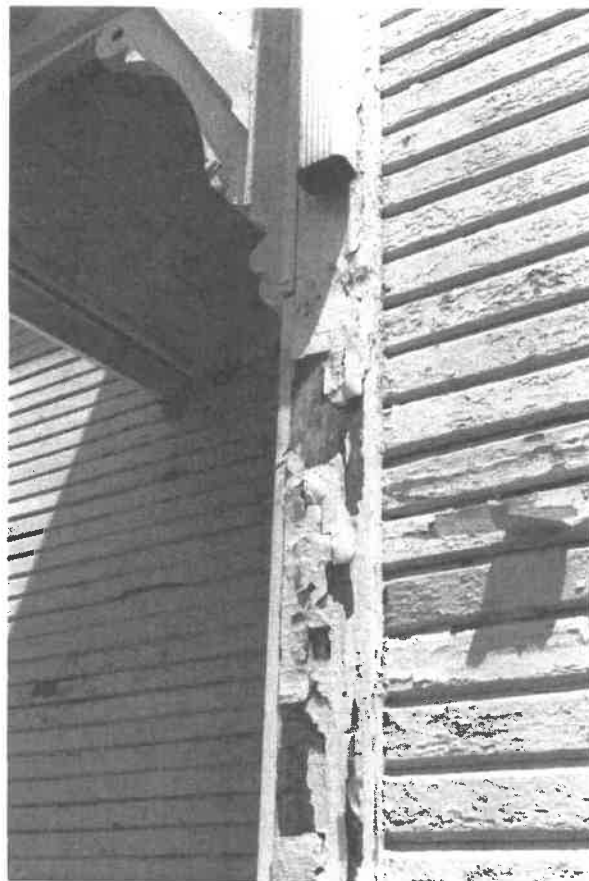
Poor practice — A broken downspout is allowing an excessive amount of water to pour down the side of this house, causing paint to peel and deterioration of the wood.

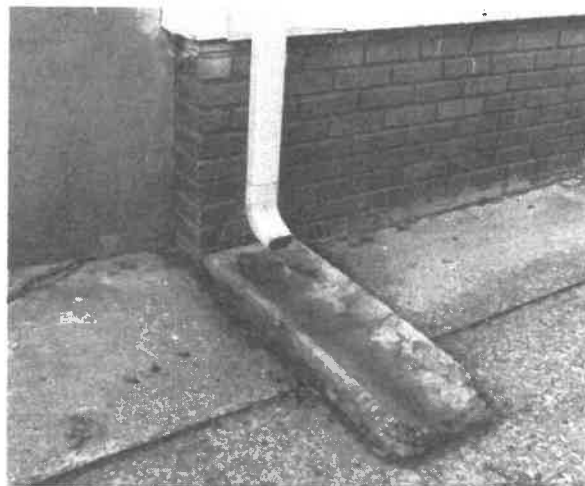
This splashblock diverts water away from the building's foundation.

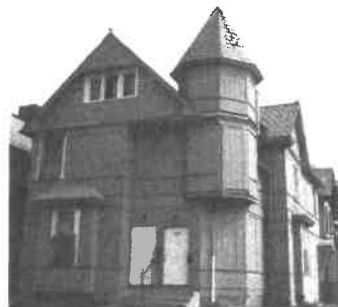
This Queen Anne house has lost much of its former character through application of inappropriate siding. Windows have been covered up with vertical wood boards while the rest of the house has been covered with stucco.

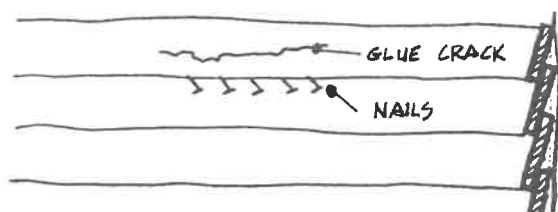
CRACK REPAIR

CRACK REPAIR: APPLY WATERPROOF GLUE TO BOTH SIDES OF THE CRACK, THEN CLAMP THE BOARD WITH NAILS (LEAVING 1/4" OF THE NAIL HEAD EXPOSED FOR REMOVAL) UNTIL THE GLUE SETS. REMOVE NAILS, FILL HOLES WITH PUTTY, SAND AND REPAINT.

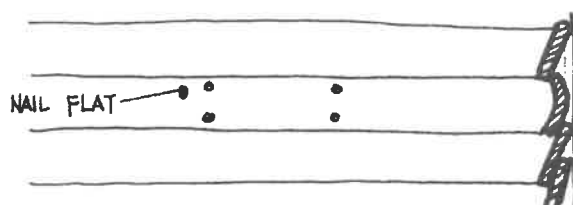
CONCAVE WARP REPAIR

CONCAVE WARP REPAIR: DRILL SETS OF HOLES NEAR THE OUTER EDGES OF THE BOARD AND DRIVE FINISHING NAILS INTO THESE TO FORCE THE EDGES BACK DOWN. COUNTER-SINK NAILS, FILL HOLES WITH WOOD PUTTY, SAND AND PAINT.

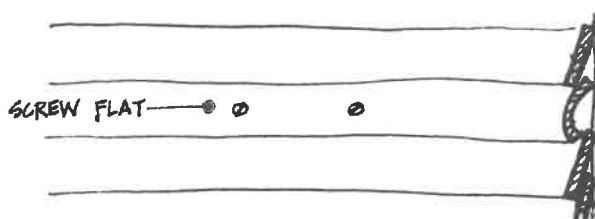
CONVEX WARP REPAIR

CONVEX WARP REPAIR: DRILL HOLES ALONG THE CENTER OF THE BOARD AND GRADUALLY SCREW IN FLAT HEAD WOOD SCREWS TO FASTEN. WETTING THE BOARD MAY KEEP IT FROM SPLITTING. COUNTERSINK SCREWS, FILL HOLES WITH WOOD PUTTY, SAND AND PAINT.

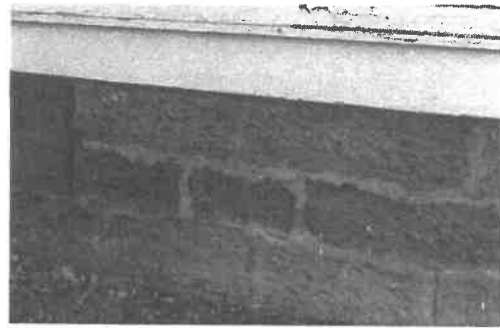
Sandstone block foundation with a tooled surface. The repointing in this example is poorly done — notice how the mortar is smeared on the surface of the stone.

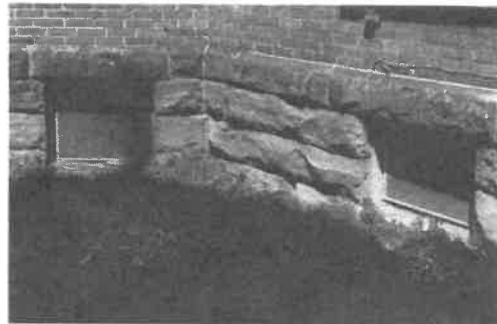
A typical sandstone block foundation in Mansfield.

Once you have improved site drainage, make sure that your basement or crawl space is kept well ventilated and dehumidified, if necessary. Repoint any deteriorated mortar in the foundation to close up gaps where moisture might penetrate. Give the area a chance to dry out before taking any other action. If the wet basement persists, the inside walls can be coated with a cement-based paint to make the basement watertight. In extreme cases, you may need to have the ground around the foundation excavated and a new drainage system installed. This latter action should not be done without professional advice.

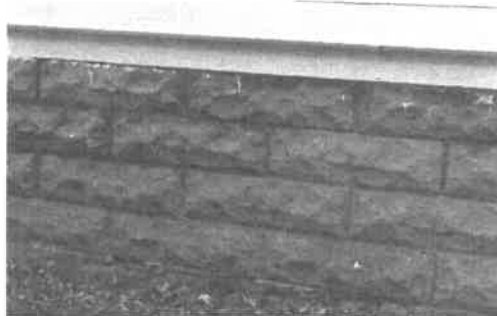
Rock-faced concrete block foundation.

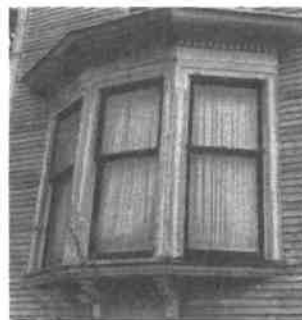
An oriel window (a projecting window which does not touch the ground).

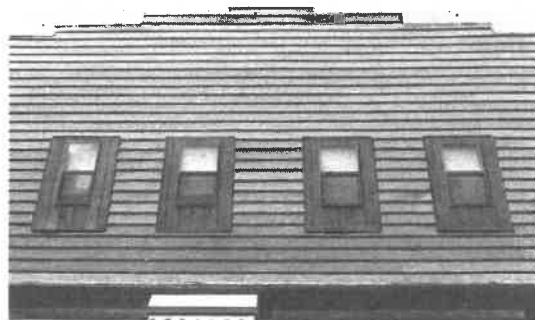
The window openings in this building have been cut down in size to accommodate a too-small window. You can see how this change has compromised the original appearance of the building.

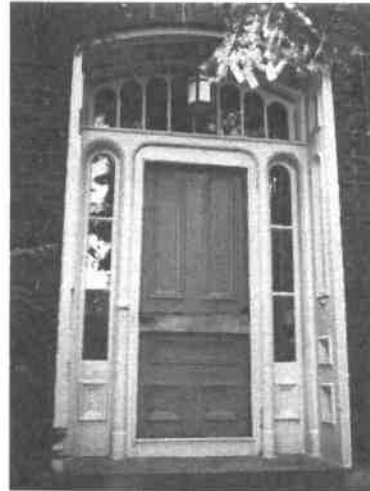
An Italianate door with delicate arched transom and sidelights.

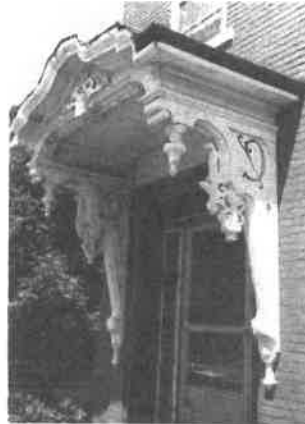
An ornate entrance hood on an Italianate house.

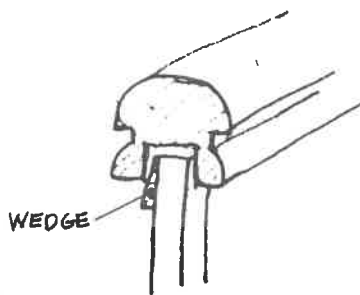
LOOSE BALUSTER: REPAIR A LOOSE BALUSTER BY USING A WEDGE TO SECURE THE RAIL.

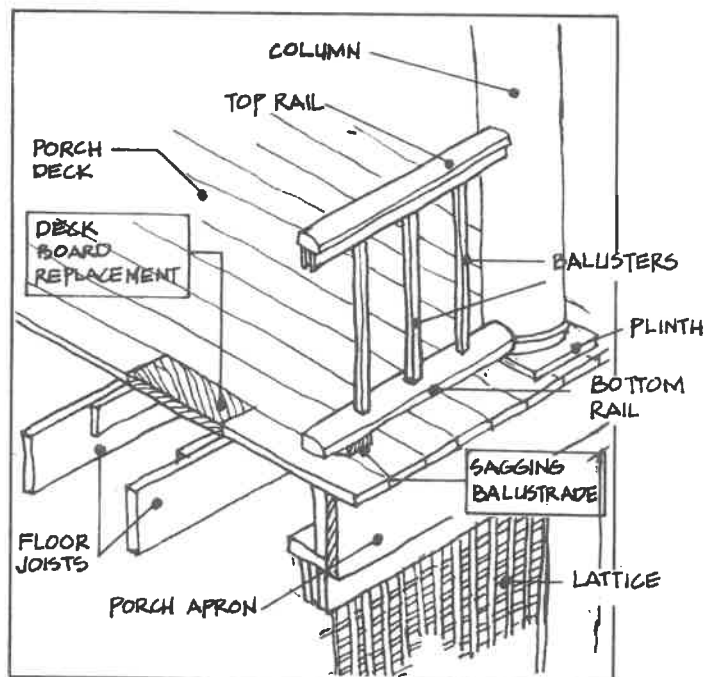
DECK BOARD REPLACEMENT: CUT OUT THE DAMAGED SECTION. CUT A NEW BOARD TO FIT, TREAT WITH A WOOD PRESERVATIVE AND BACK PRIME. NAIL 2x4'S TO THE FLOOR JOISTS TO SUPPORT THE NEW BOARD AND NAIL INTO PLACE.

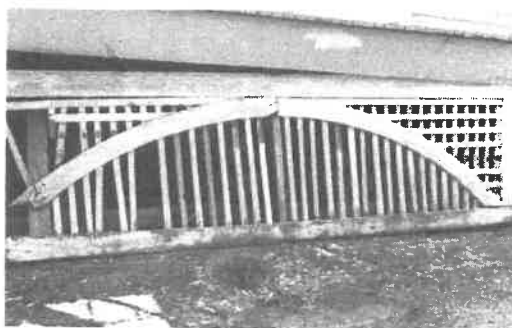
Keep wood lattice beneath the porch in good repair.

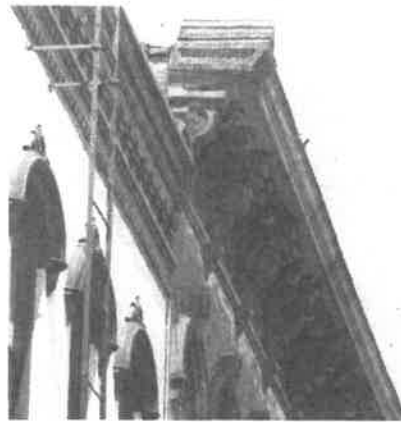
A pressed metal cornice on a North Main Street commercial building.

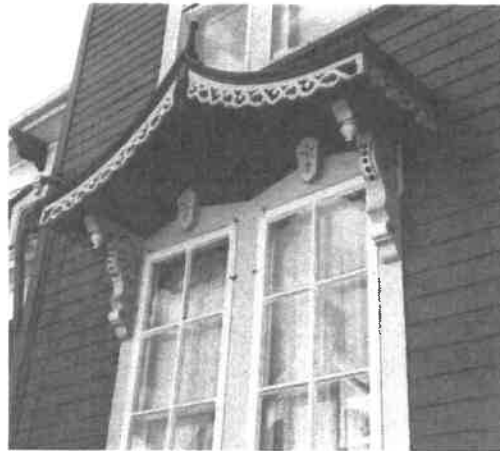
Sawn and turned wood ornament includes a decorative window hood and cornice brackets.

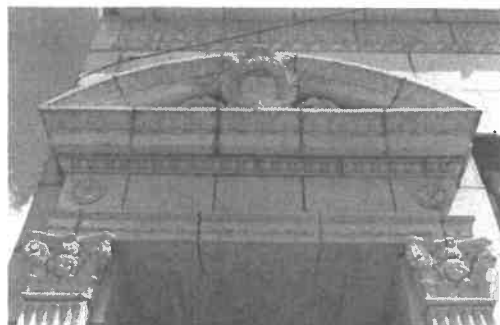
Terra cotta facing and ornamentation on the facade of the Renaissance Theater.

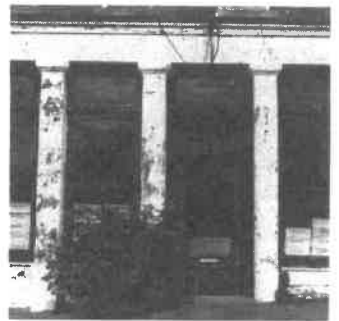
Although paint encrusted and dirty, this storefront has its original features intact, including the piers, windows and front door.

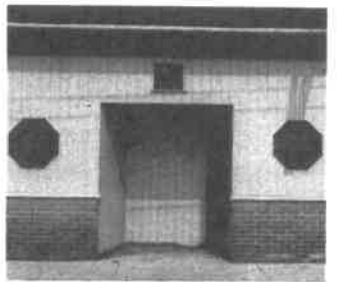
The original storefront has been completely changed in this example. Part or all of the original storefront may be hiding beneath new materials.

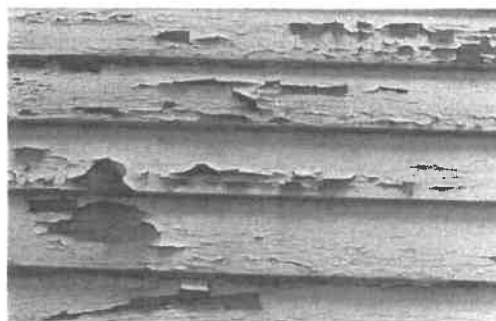
Paint peeling to bare wood is usually caused by an interior or exterior moisture problem. Always correct the problem before taking any other action.

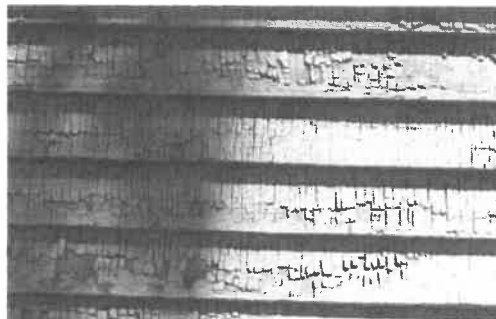
Alligatoring or cracking results when paint that is many layers thick becomes brittle and can't expand and contract with the wood. Moisture penetrates the cracks, causing deeper cracks to form.

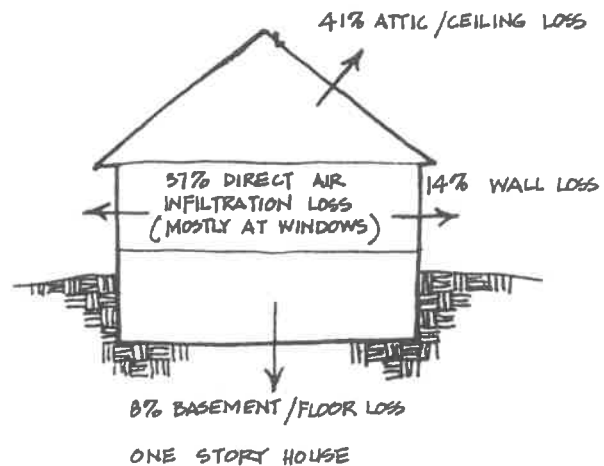
These drawings show the average heat loss for an older house which does not have insulation, storm windows or weatherstripping. (Adapted from *Insulating the Old House*, compiled and edited by Sally E. Neilsen (Portland, Maine: Greater Portland Landmarks, Inc., 1977 and 1978,) pp. 8-10.)

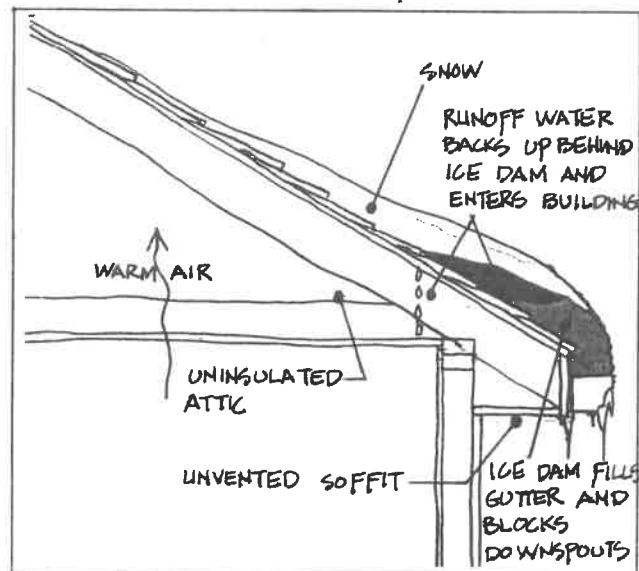
ICE DAMS CAN BE CAUSED WHEN THE WARMED ROOF MELTS SNOW AND THE WATER RUNOFF FREEZES OVER THE UNHEATED EAVE. SUBSEQUENT RUNOFF STOPPED BY THE ICE DAM BACKS UP UNDER SHINGLES AND ENTERS BUILDING. ICE DAMS CAN ALSO CAUSE THE GUTTERS AND EVEN THE EAVES TO FALL OFF.

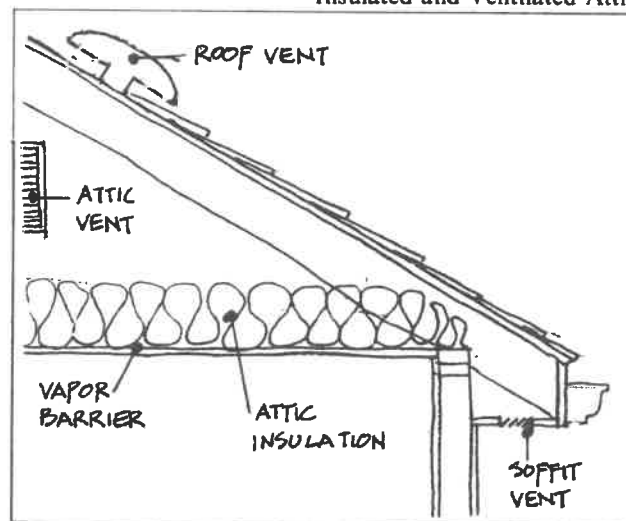
PROPERLY-INSTALLED INSULATION (WITH A VAPOR BARRIER) WILL REDUCE PENETRATION OF WARM AIR TO THE ROOF. ADEQUATE VENTILATION IS IMPORTANT TO ALLOW OUTSIDE AIR TO CIRCULATE ABOVE THE INSULATION. THIS DRAWING SHOWS THREE TYPES OF ROOF VENTS WHICH MAY BE USED.

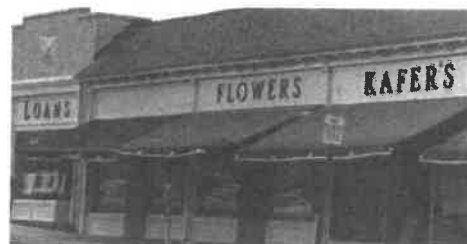
Awnings provide passive energy conservation. Canvas awnings like these are appropriate on downtown commercial buildings.
